# NATIONAL ADVISORY COMMITTEE FOR AERONAUTICS

TECHNICAL NOTE 3190

## FATIGUE INVESTIGATION OF FULL-SCALE TRANSPORT-AIRPLANE WINGS

SUMMARY OF CONSTANT-AMPLITUDE TESTS THROUGH 1953

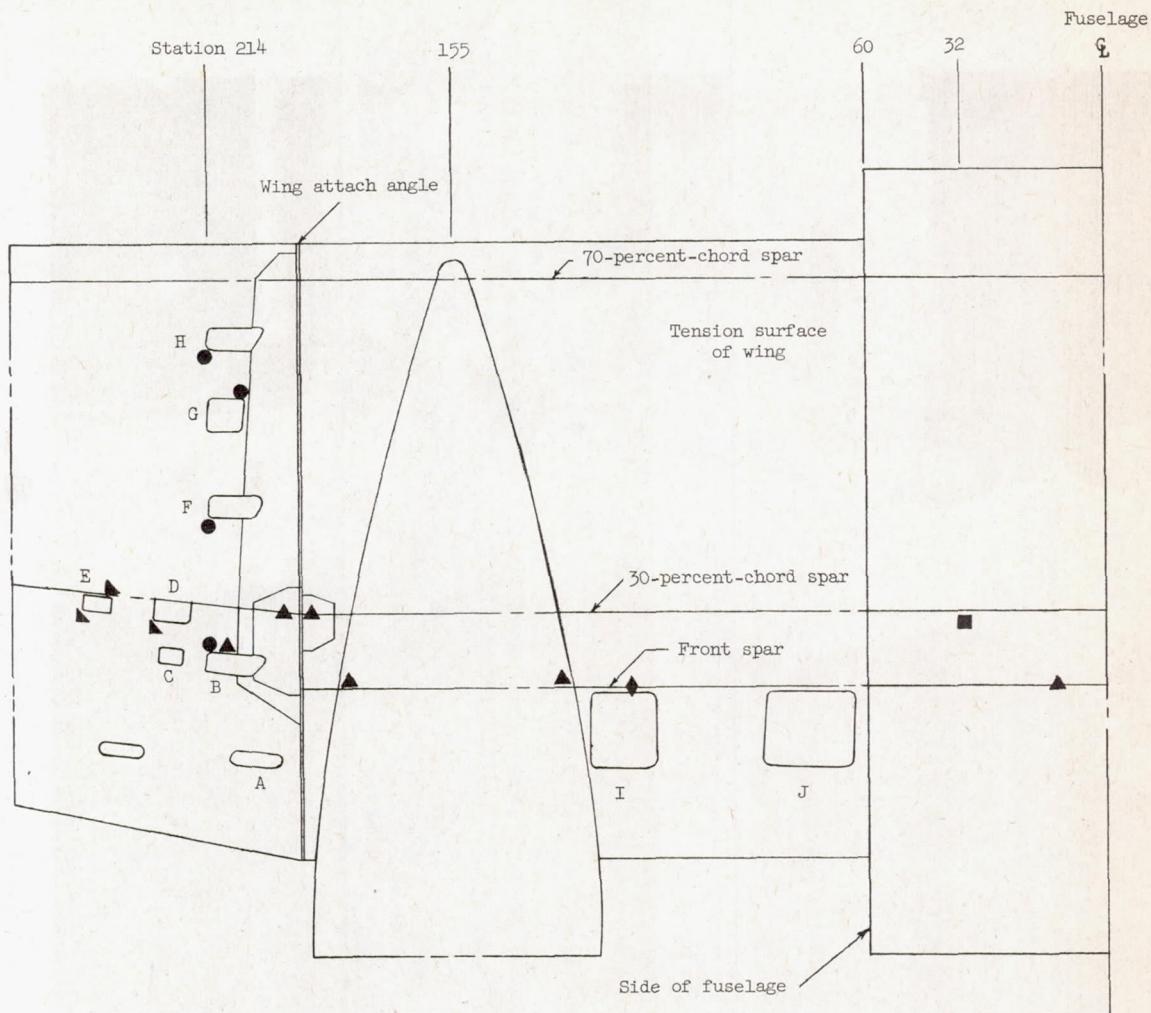
The five types and their locations are shown in the plan view of the tension surface in figure 5, and are illustrated in figures 6 and 7. Most of these types of failures occurred in stress raisers which would be present in similar form on almost any metal aircraft structure.

Figure 5.- Locations and types of fatigue failures.

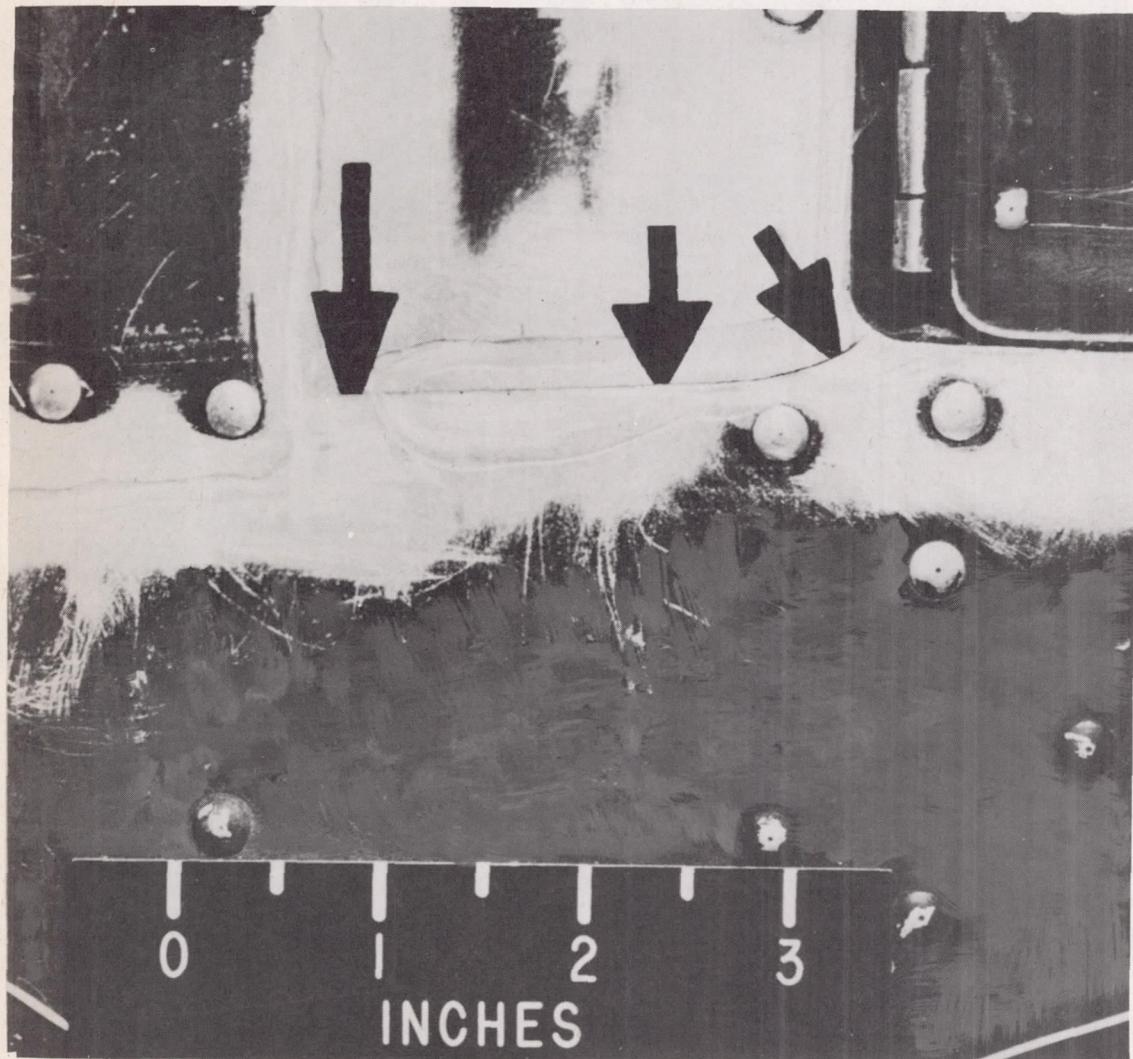
L-77922.4

The type I failures originated in the corners of inspection cutouts B, F, G, and H, and examples are shown in figures 6(a) and 6(b). These cutouts had non-load-carrying covers and were all at span station 214. Most of the failures occurred in the vicinity of the spar at the 30-percent-chord position, which was the most highly stressed region as indicated by the chordwise stress-distribution survey at this station. Since span station 214 contained numerous cutouts, doublers, and other discontinuities and therefore yielded an irregular stress distribution, another chordwise survey was made at span station 235, which was the nearest station that was free of these discontinuities. The gages used in these surveys were oriented so as to measure the strain in a spanwise direction. The results of these surveys are presented in figure 8, along with a cross section of the tension surface at span station 214. This figure indicates that for both of these stations the highest stress occurs in the vicinity of the 30-percent spar.

(a) Type I failure at forward outboard corner of inspection cutout F.

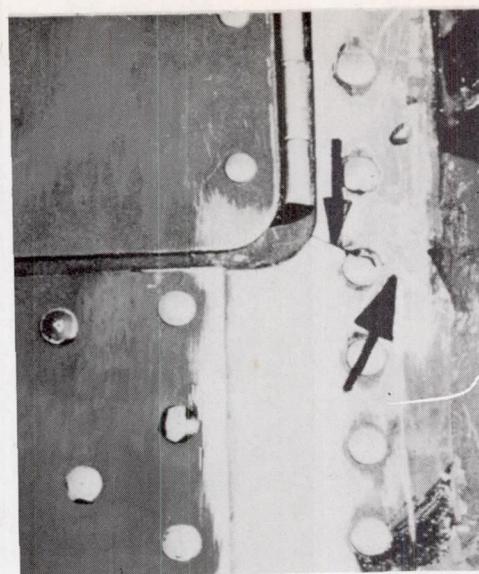
L-77923.1

(b) Type I failure at forward outboard corner of inspection cutout H.

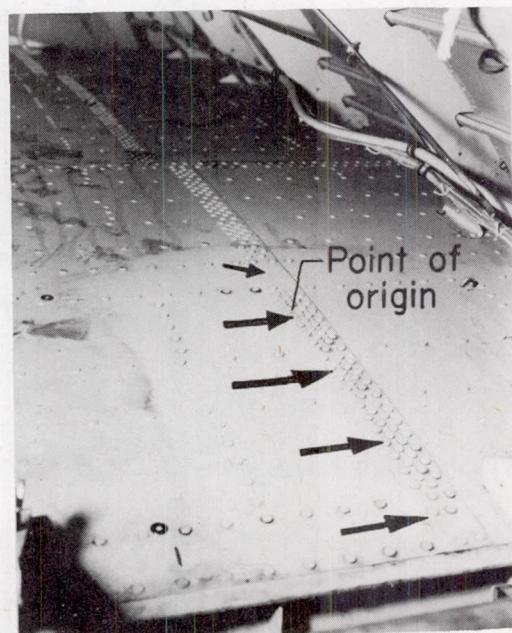
L-65799.2

The type II failures, which originated in riveted tension joints, all occurred at span station 32 inside the fuselage in the vicinity of the 30-percent spar. A photograph of this type of failure is shown as figure 6(c). A chordwise distribution of stress at span station 32 was included in reference 1 and indicated that the higher stresses again occurred in the vicinity of the 30-percent spar. These failures were consistent during the earlier tests but did not occur during the later tests because of the reinforcing strip previously described.

(c) Type II failure in riveted tension joint.

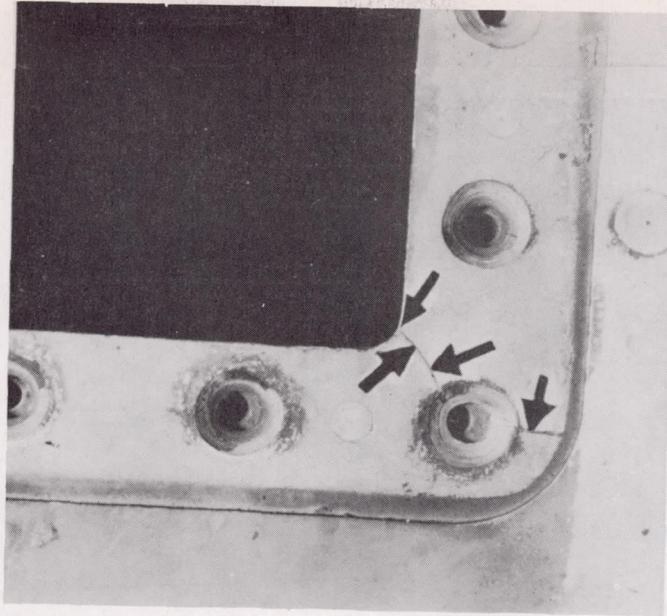
L-77924

The type IV failures occurred in internal reinforcing doubler plates around cutouts D and E, located outboard of span station 214 and immediately forward of the 30-percent spar. A photograph of this type of failure is presented as figure 6(d). These cutouts had cover plates that were fastened to the reinforcing doubler plate with machine screws and channel nuts. The failures originated in the screw holes on some wings and in the smaller-radius corner of the internal doubler plate on others, frequently occurring very early in a test. These failures spread into the skin on only two occasions but in no case did they grow to more than a few inches in length.

(d) Type IV failure in reinforcing doubler plate at inspection cutout D.

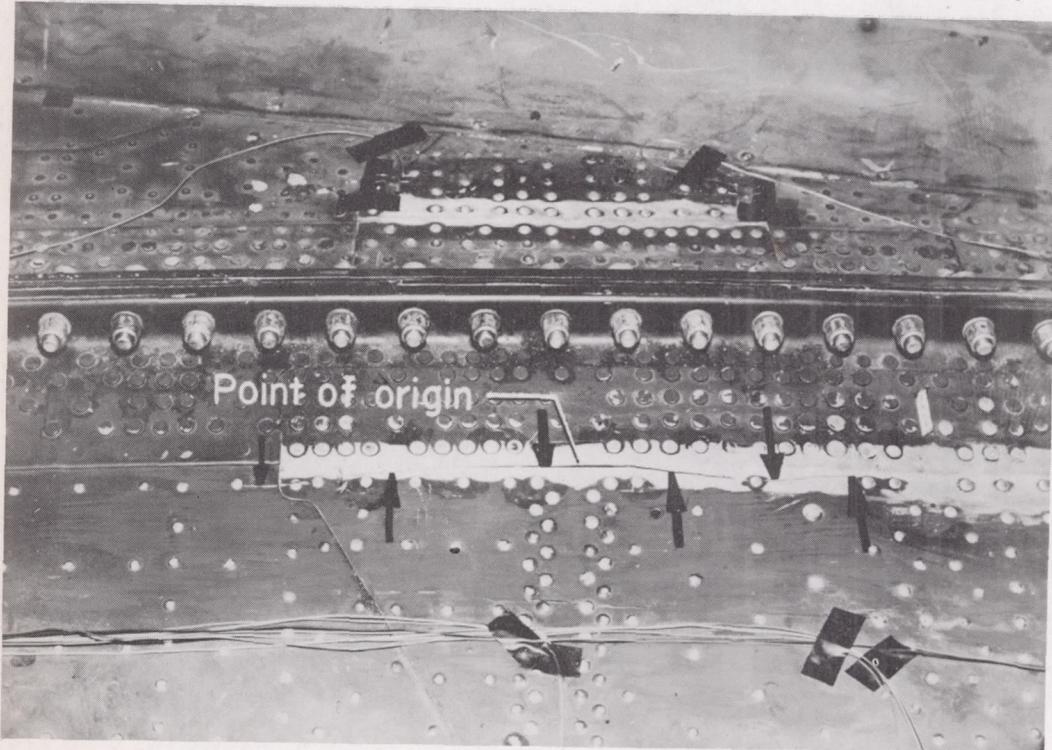
L-67351.1

(e) Type V failure in joggle in external reinforcing doubler plate.

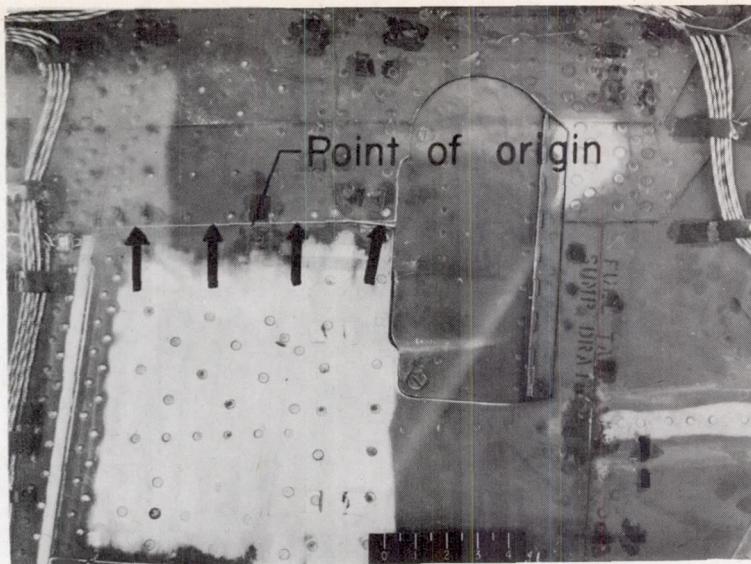
L-81785.2

(f) Type V failure at edge of external reinforcing doubler plate between cutout B and 30-percent-chord spar.

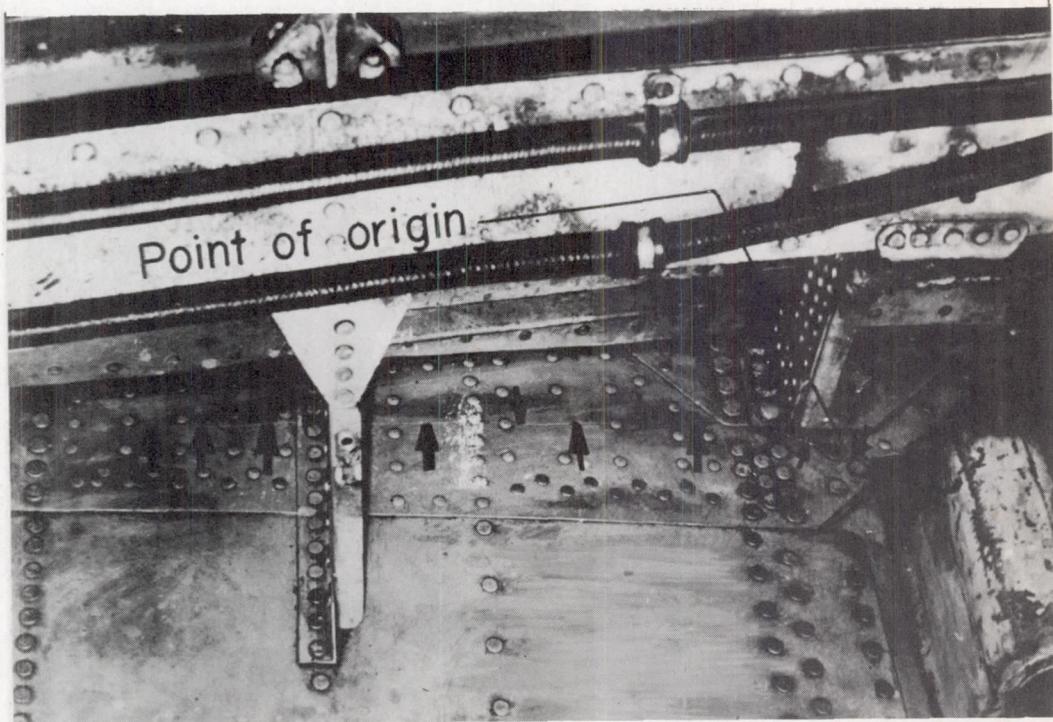
L-67783.1

Type V includes all the failures that could not be classified in one of the preceding types. Several failure locations are included in this type, but at only three of these did failures repeatedly occur. One of these locations was in a joggle in an external doubler plate about 3 inches outboard of the wing attach angle and directly over the 30-percent spar. These failures occurred only at the two highest load levels and an example is presented in figure 6(e). Another type V failure occurred in the skin at the edge of the external attach-angle doubler plate, between the 30-percent spar and cutout B. A photograph of this failure location is presented as figure 6(f). Strain-gage measurements indicated this region to have a higher nominal stress than any other location where strain-gage measurements were made. These failures occurred at every test level. Another failure location of type V was inside the engine nacelles at span station 180 in a doubler plate over the front spar. A notch had been cut in the edge of the doubler plate to allow clearance for the rotation of the landing-gear strut during extension and retraction of the landing gear, and the failures started either in the notch or at a rivet near the notch. In some cases the notch had been hand cut and in others the notch was cut by rotation of the landing-gear strut itself. A photograph of this failure is presented as figure 6(g).

(g) Type V failure inside engine nacelle.

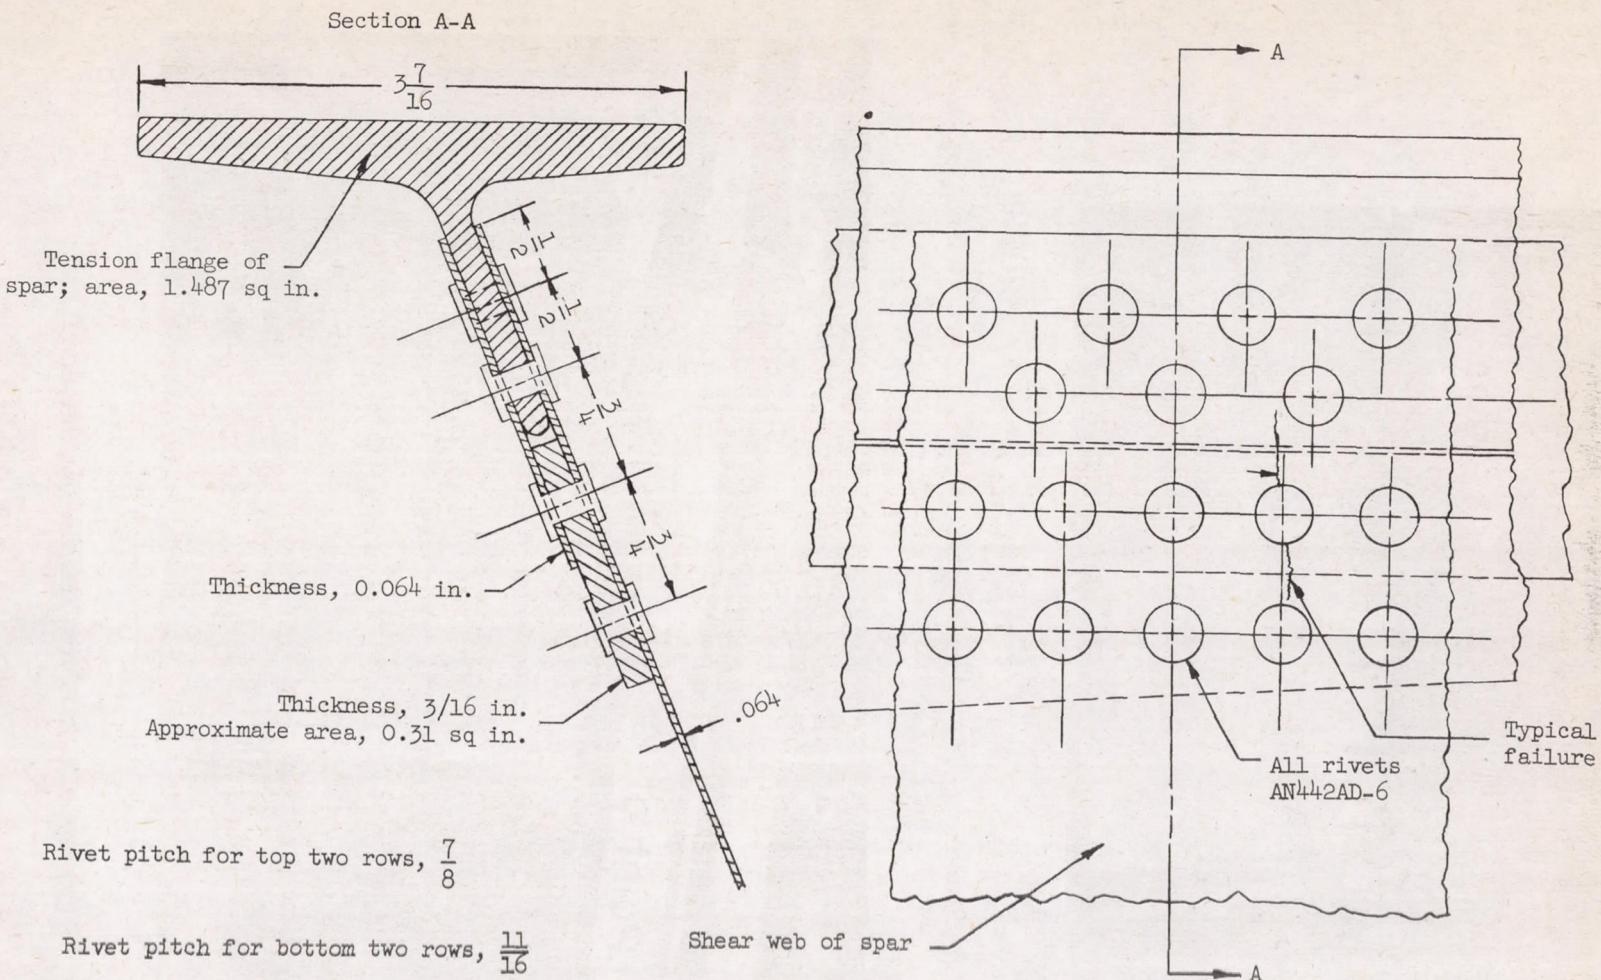
The type III failures occurred at span station 120 in the riveted joint connecting the shear web to the tension flange of the front spar. Since this location was very difficult to photograph, a drawing of the details of this joint is shown in figure 7. The cracks usually progressed vertically through the shear web and were accompanied by a crack in a small piece of skin over the spar cap.

Figure 7.- Details of riveted shear joint at span station 120 in which type III failures occurred.

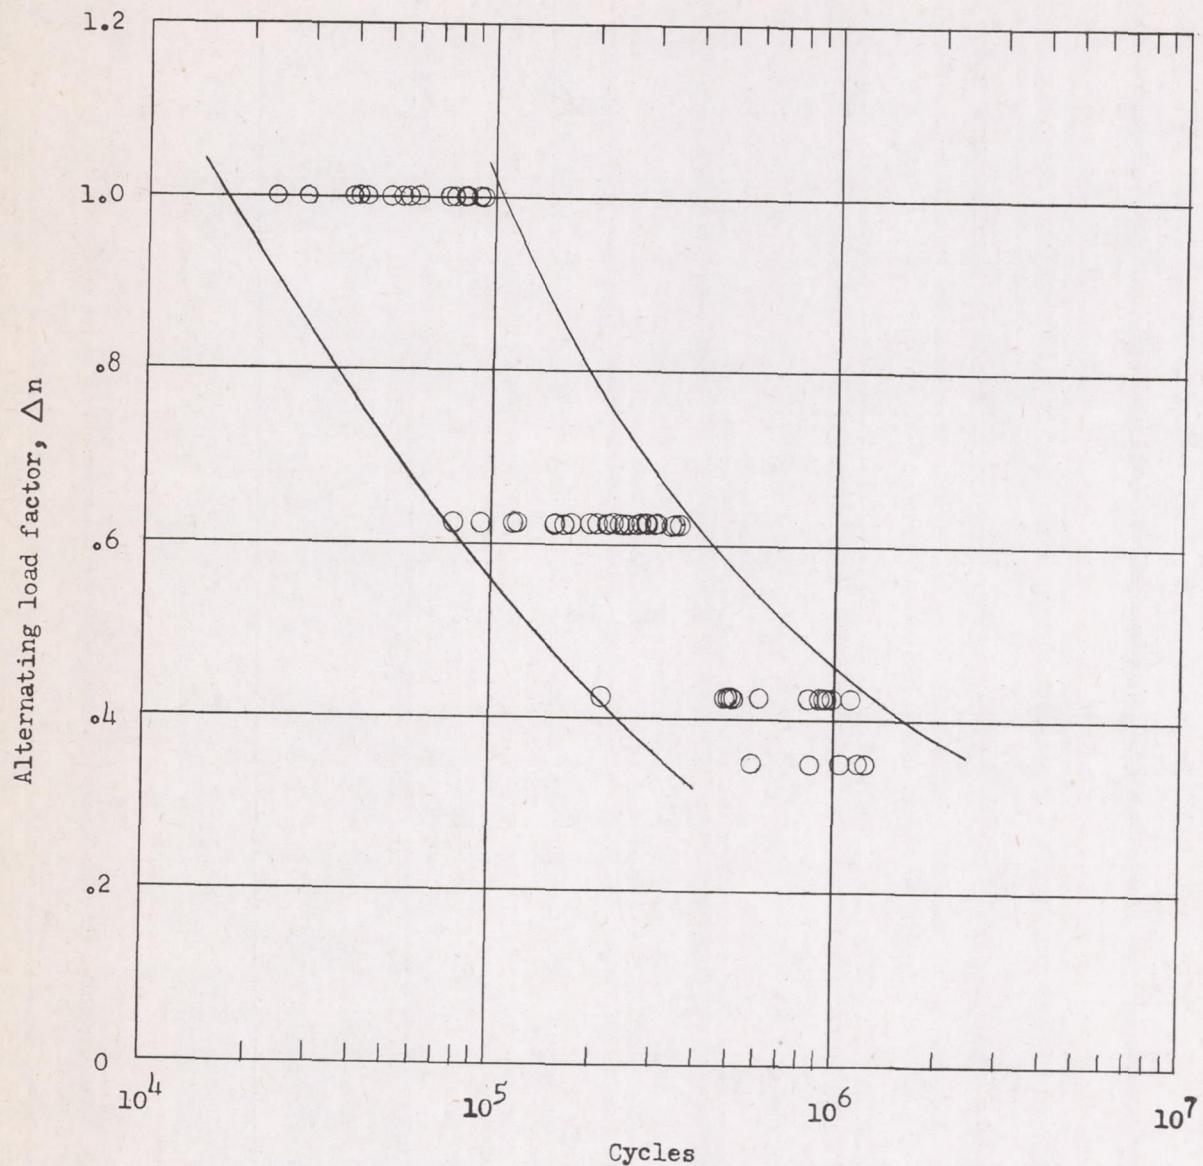
From the probability curves, data were obtained with which to plot the load-lifetime diagram of figure 9, in which a scatter band is shown. This scatter band indicates the limits within which 95 percent of all failures should occur at each level, as determined by the theory of extreme values. Also shown in this figure are the actual data points obtained from the fatigue tests.

Figure 9.- Load-lifetime diagram for initial failure showing scatter band for 95-percent probability.

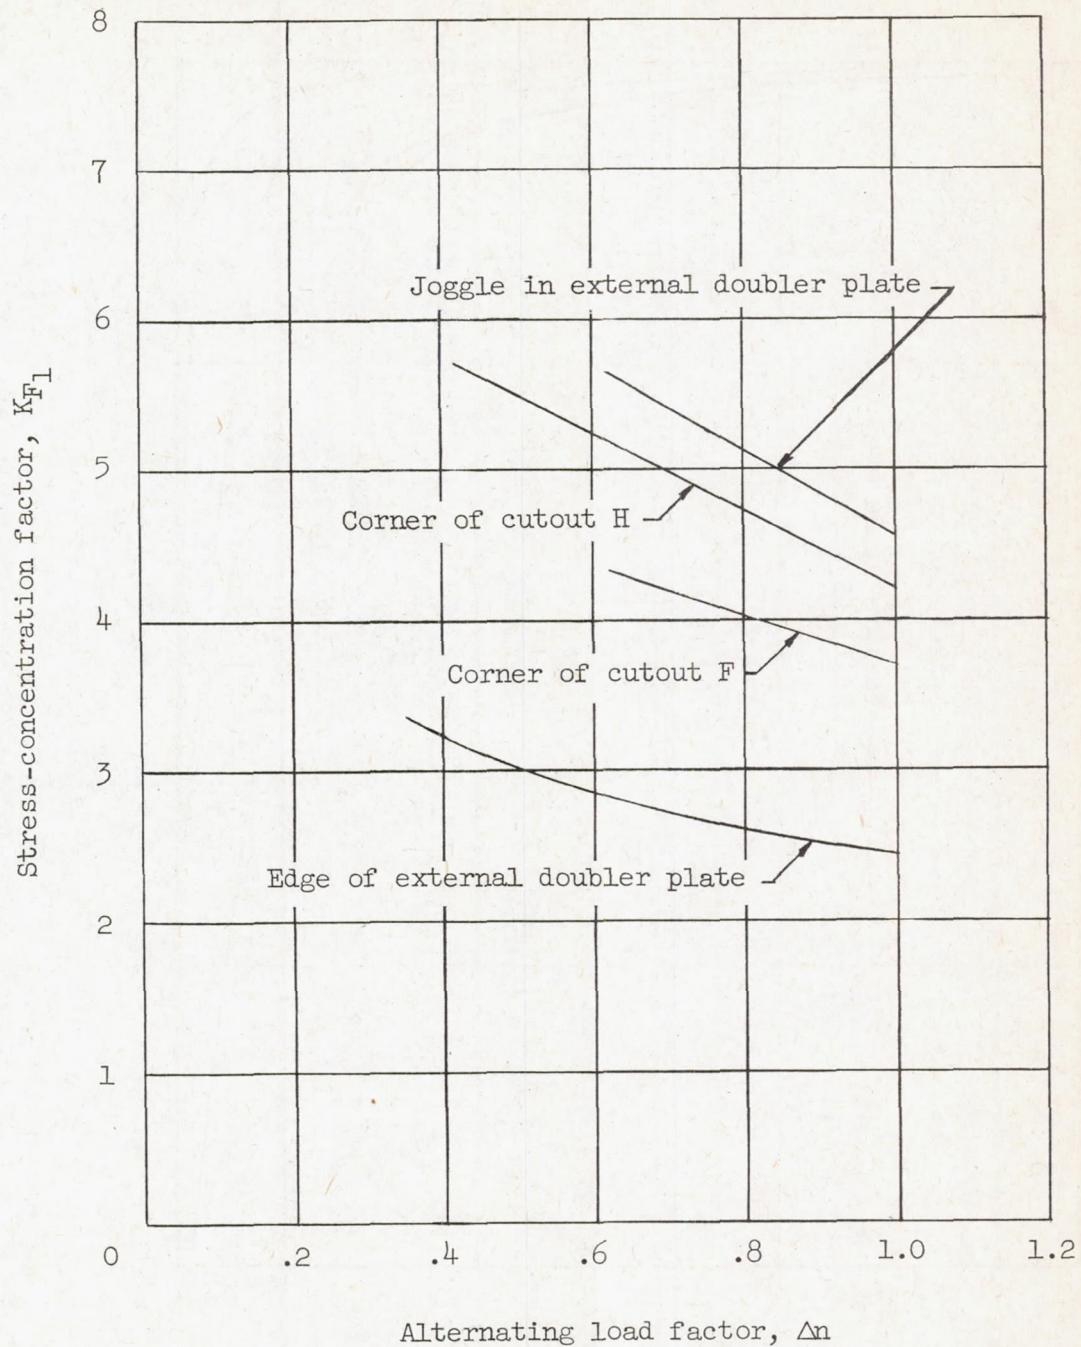
The range of concentration factor  $K_{F1}$  occurring at each load level for the five types of failures is shown in table 2. It can be noted from this table that the concentration factor tends to decrease with increasing load level. This trend is shown graphically in figure 10 for several locations where failures occurred at more than one load level. The trend is assumed to be caused by the increasing effects of plasticity associated with higher stresses as the load level is increased. Both  $K_{F2}$  and  $K_{F3}$  show the same decreasing trend with increasing load level that  $K_{F1}$  does, but in the case of  $K_{F3}$  the trend is not very apparent because of the lower magnitudes involved.

Figure 10.- Effect of load level on the stress-concentration factor.

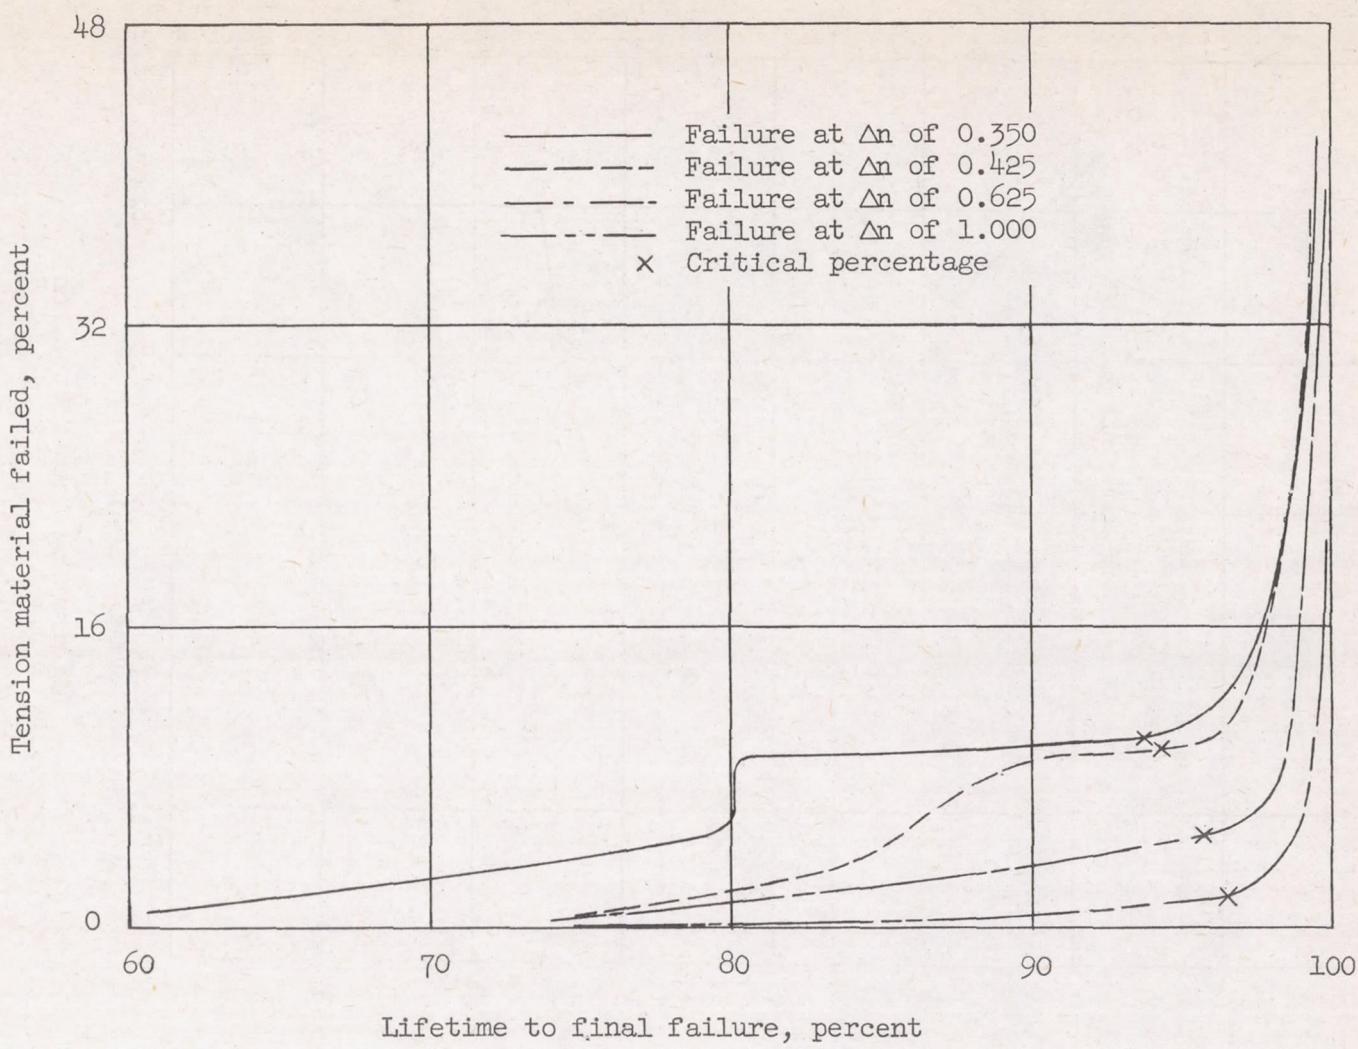
The growth of all fatigue cracks was observed during the course of the tests. In figure 11 the growth of typical failures is plotted for each of the test levels. In order to put all failures on the same comparative basis, the percentage of tension material failed in a cross section of the wing is plotted against the percentage of lifetime to final failure. In this figure it can be noted that all of the curves have the same general shape. In each case the failure grew slowly until a certain percentage of the tension material had failed. At this point, defined as the critical point, the growth of the cracks became very rapid. The percentage of tension material that had failed at the critical point decreased with increasing load level. For the 0.35g level the amount of tension material that had failed at the critical point was about 10 percent; for the 0.425g level, about 9 percent; for the 0.625g level, about 6 percent; and for the 1.0g level, about 2 percent. This critical point occurred at about 95 percent of the lifetime to final failure for all test levels. Tests of all specimens were continued until the critical point had been determined.

Figure 11.- Typical fatigue-crack propagation.

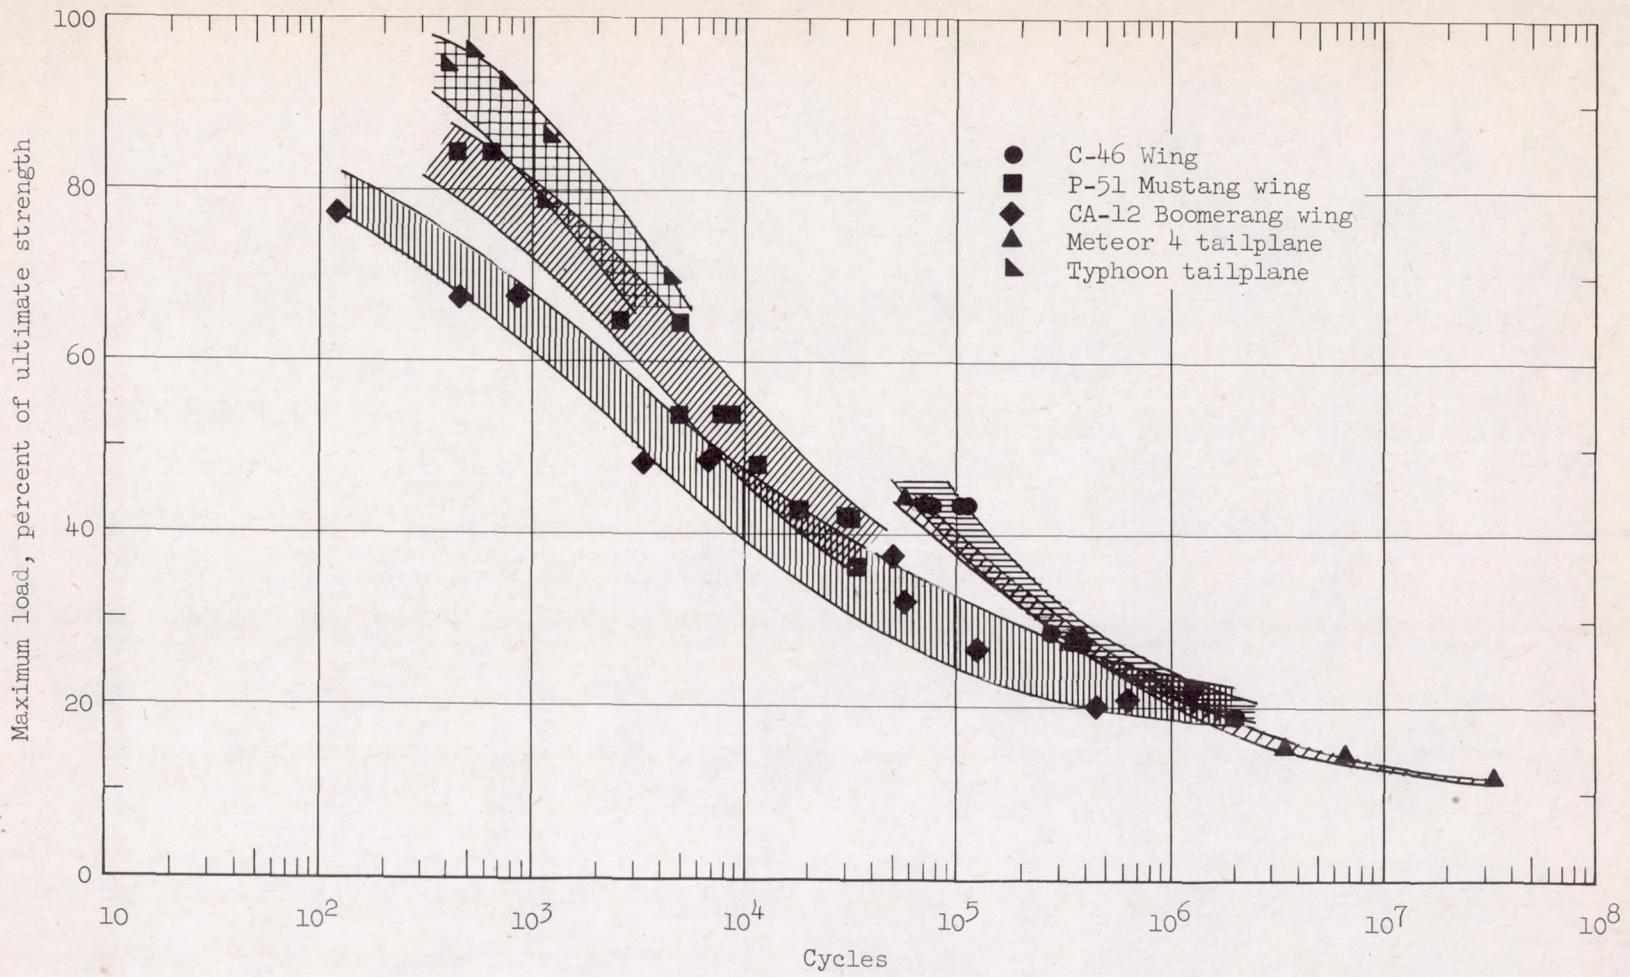
The load-lifetime diagram for final failure is presented in figure 13, along with results of fatigue tests on a number of other airplane structures taken from references 7 to 10. The load is given in percent of the ultimate static strength of the structure. It can be seen from this figure that all of the full-scale data presented lie within a comparatively narrow scatter band, considering the fact that the data include different types of airplanes and components with many types of stress raisers. Full-scale fatigue data from other airplanes have been found to fall within the scatter of the data that are presented.

Since the ordinate of figure 13 is based on the ultimate strength of the structures and since fatigue failures occurred principally on the tension surface, the load-lifetime comparison could best be made on the basis of the ultimate strength of that surface. In the static tests to determine the ultimate strength of the structures in references 7 to 10, the P-51 wing and Meteor 4 tailplane failed in compression while the remaining structures failed in tension. The C-46 curve in this figure is based on the design ultimate strength of the wing, because the actual ultimate strength is unknown. In static tests performed by the U. S. Air Force the wing failed in compression at 95 percent of the design ultimate load, and was subsequently reinforced but not retested.

If, in the case of those structures which failed in compression, the strength of the tension surface is assumed to be greater than the strength used in the comparison of figure 13, the load-lifetime curves would be shifted downward. This downward shift would very likely result in even less scatter in the data of this figure than is now present.

Figure 13.- Load-lifetime diagrams for several aircraft structures.

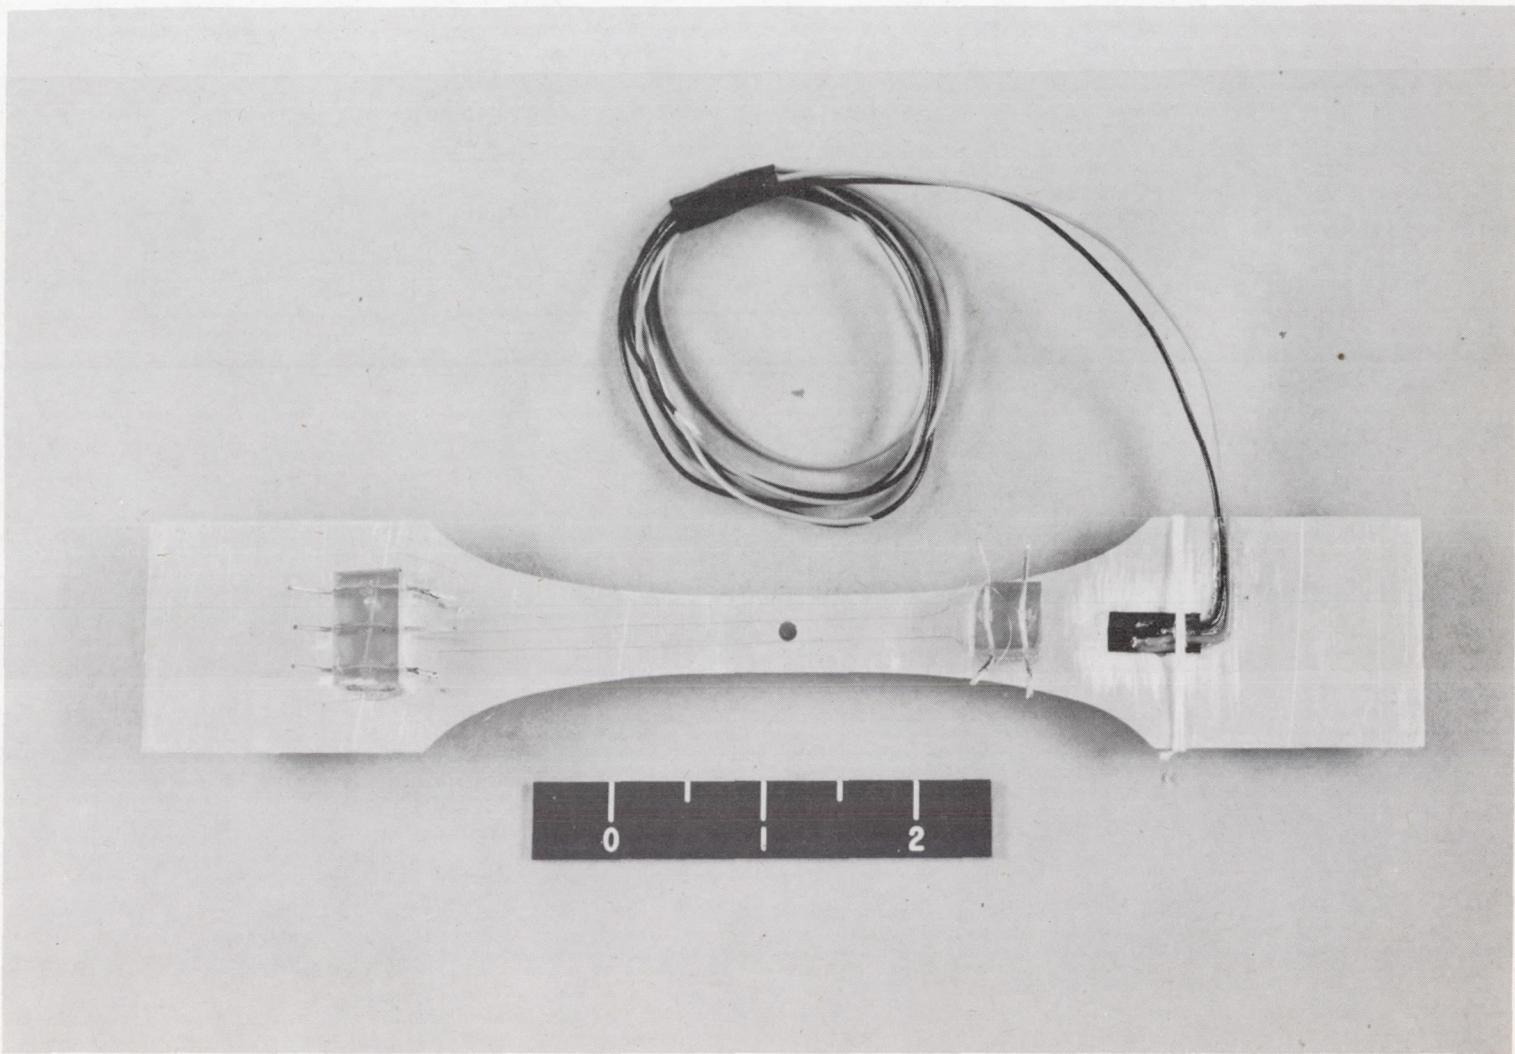
L-76744

A typical test specimen is shown in figure 14. These test specimens were cut from 0.032-inch-thick 24S-T aluminum-alloy sheet and contained a stress raiser in the form of a drilled hole or notch to localize the area of fatigue-crack formation.

Figure 14.-- Test specimen with a hole as a stress raiser. Fatigue-crack detector wire shown mounted close to hole.

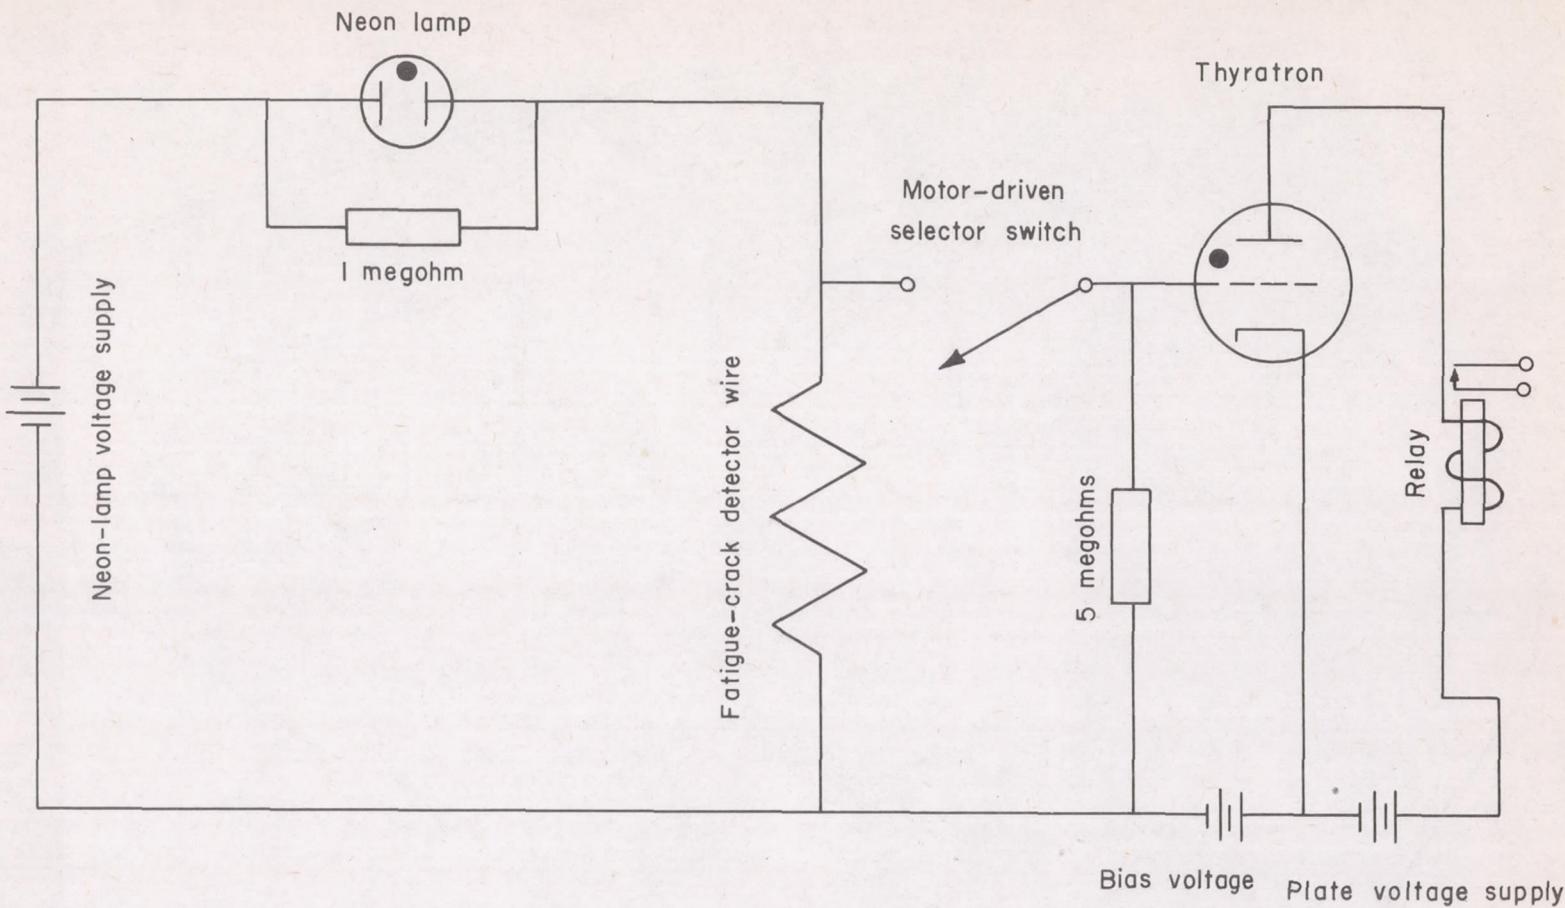
The application of these detector wires to the fatigue tests of full-scale wings required a multiwire installation. One channel of the system used is shown schematically in figure 15. When a fatigue crack caused failure of the detector wire the neon lamp would be extinguished and the Thyratron tube would actuate the alarm circuit. By the use of a four-pole, 360 rpm selector switch, it was possible to provide, in a compact arrangement, dependable fatigue-crack indications for 56 circuits. In the process of working out suitable indicating circuits it was found that the installed annealed copper wires would safely carry currents to 0.2 ampere, and with the added insulation afforded by the Duco cement the working voltage between the wire and the test surface could be as high as 150 volts d.c.

Figure 15.- Schematic diagram of a one-channel fatigue-crack-detector-wire indicating circuit.

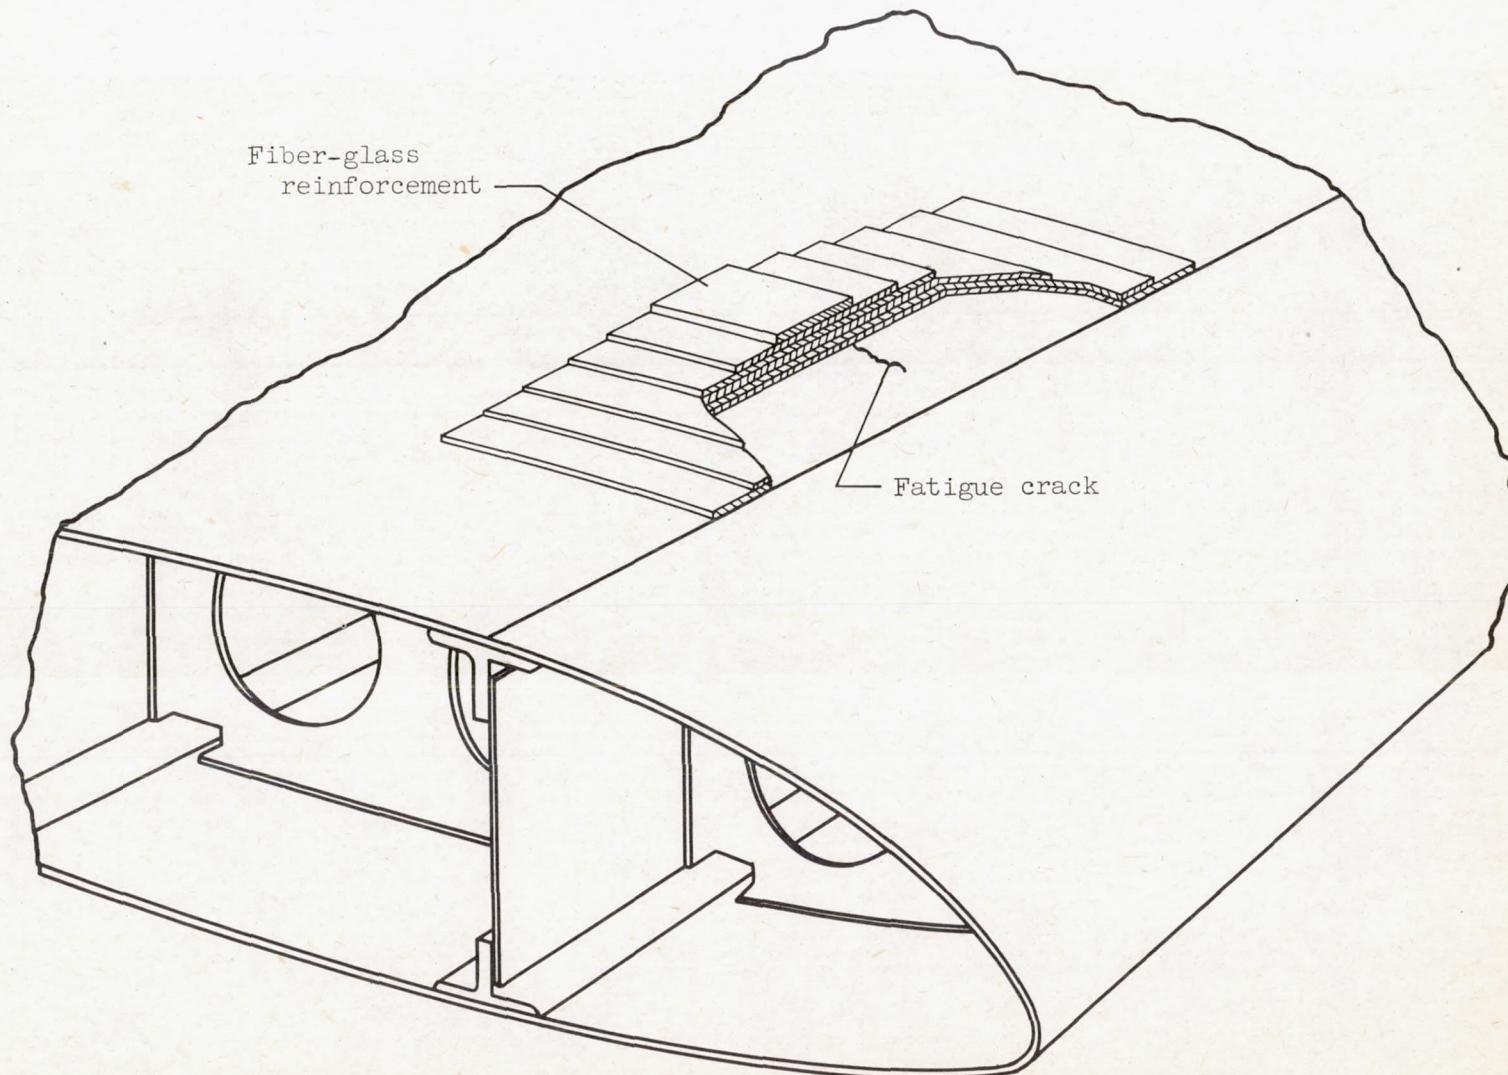
Figure 16.- Typical arrangement of fiber-glass reinforcement.

All fatigue cracks which were repaired by this method extended in essentially a chordwise direction on the tension surface of the wing. The patches were therefore designed principally to carry tension loads in a spanwise direction. For these fatigue tests the tension surface of the wing was the upper surface since the wing was mounted in the inverted position. The size of the patch required for satisfactory reinforcement naturally depended to some extent on the size of the fatigue crack to be repaired. The length and width of the reinforcement were determined by a generous estimation of the bond area necessary to secure adequate transfer of load from the wing structure to the fiber-glass reinforcement. Since the modulus of elasticity of the reinforcing material was considerably less than that of the aluminum wing structure, the thickness of reinforcement used was about five times the thickness of the structure to be repaired, so that both had about the same stiffness. All reinforcements were laminated from 10 to 16 layers of fiber-glass cloth arranged in a tapering stack which reached its maximum or design thickness over the fatigue crack. This arrangement is shown schematically in figure 16.

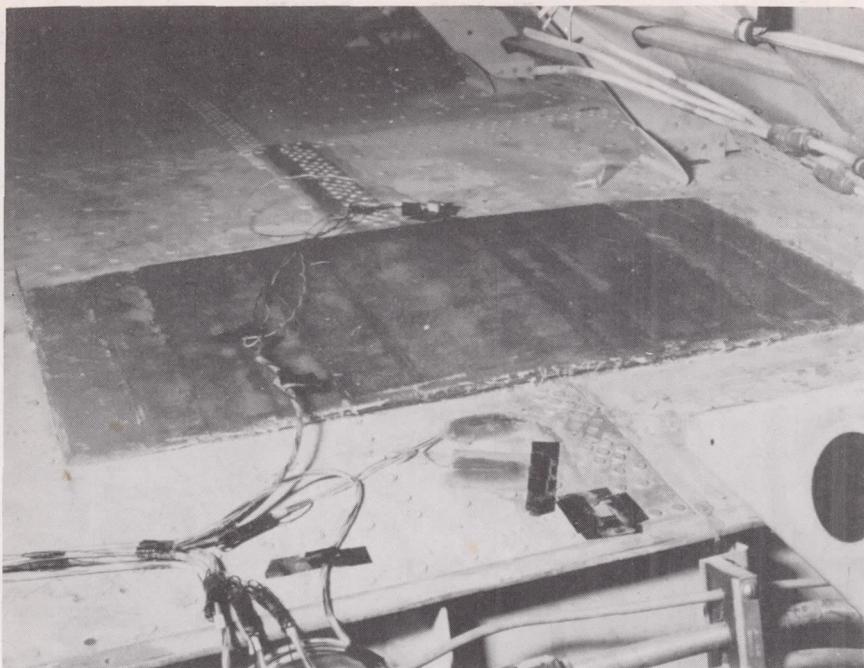
L-71724

(a) Inside fuselage at span station 32.

A number of these fiber-glass reinforcements have been used in the fatigue tests of the C-46 wings to repair structural damage resulting from fatigue cracks of several different types ranging in length from 1/4 inch to 12 inches. Two typical repairs are shown in figure 17. Part (a) of this figure shows the repair of a failure in a riveted tension joint at span station 32 similar to the failure shown in figure 6(c). Part (b) of figure 17 shows the repair of a failure inside the engine nacelle similar to the failure shown in figure 6(g). The latter location illustrates how these fiber-glass reinforcements may be cut to conform to various structural discontinuities. Repairs have also been made to the shear web of the front spar in the wing center section at station 120. In this case the fiber-glass reinforcement was applied to a vertical surface without great difficulty.
